INSTALLATION OF A SELF-SEALING MATERIALS
SYSTEM IN A C-130 INTEGRAL FUEL TANK WING

R. M. Heitz
F. Hill

Northrop Corporation
Aircraft Division

TECHNICAL REPORT AFML-TR-72-30

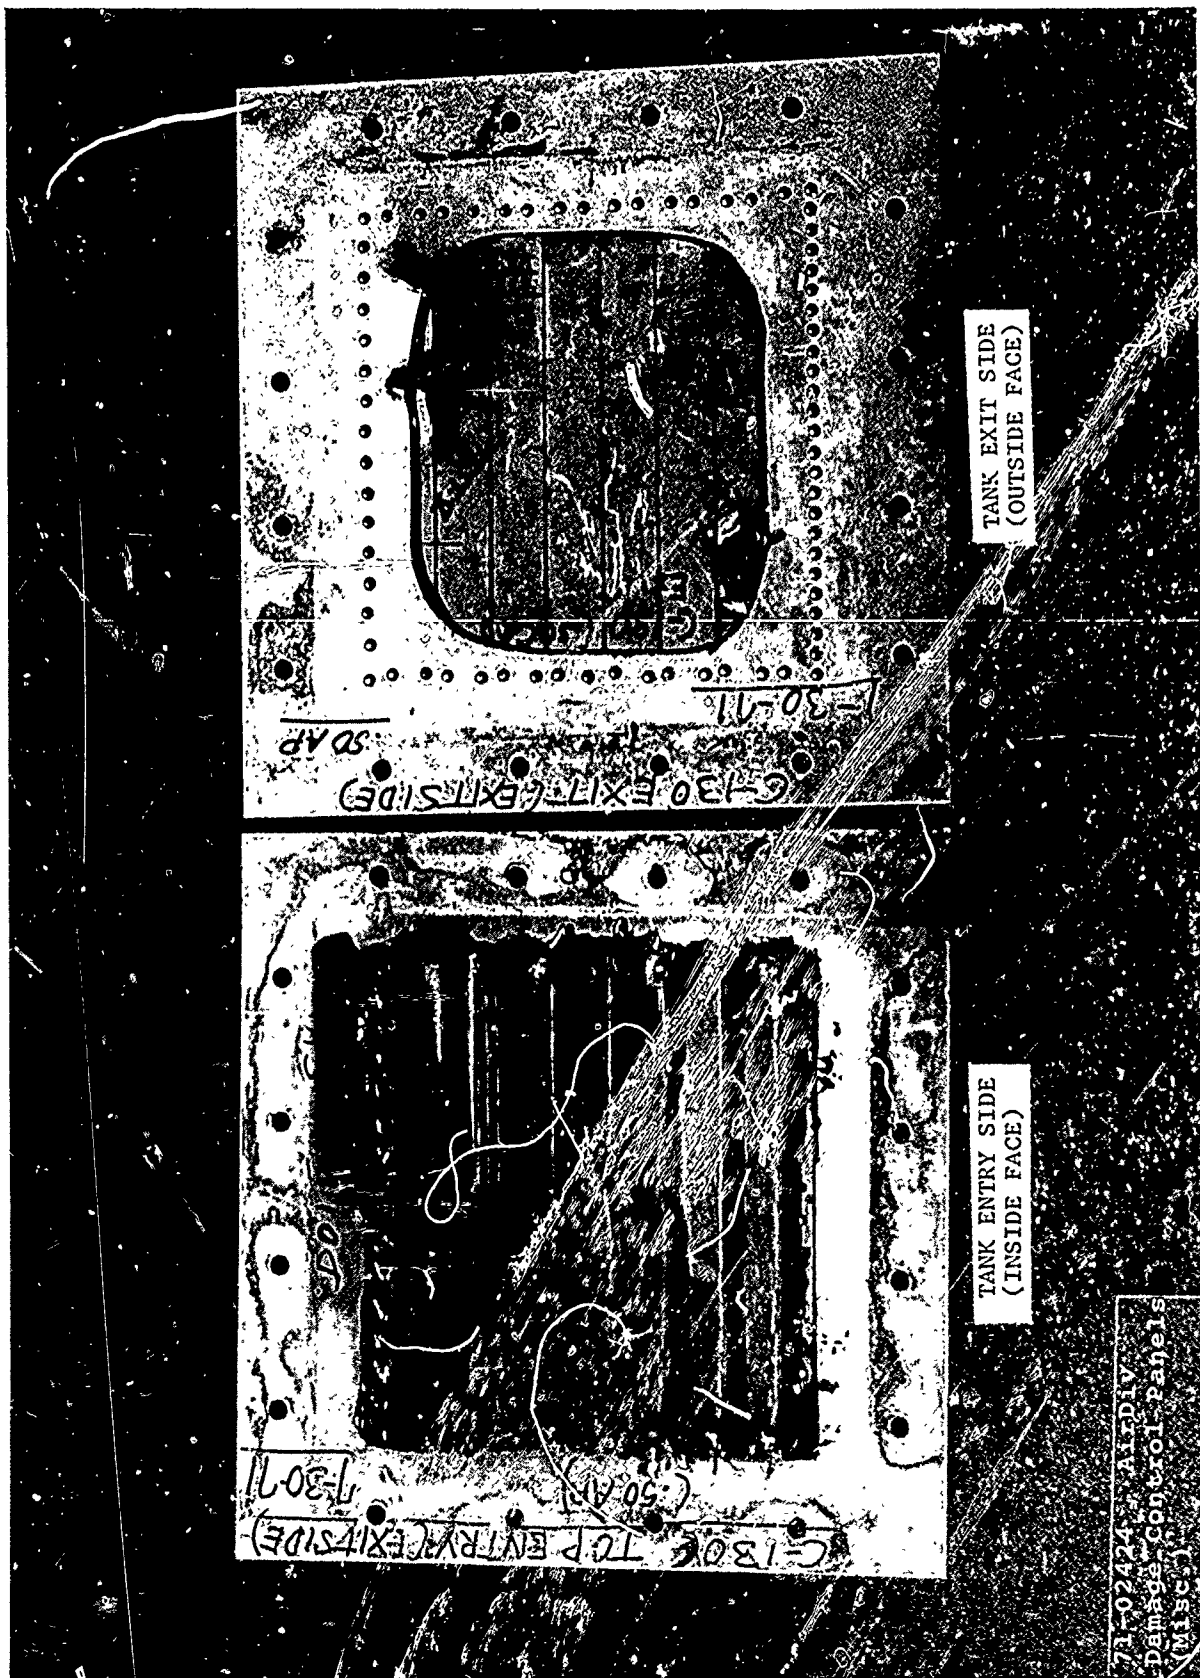
FIGURE 10. C-130 PANEL WITH DAMAGE CONTROL PROTECTION - PROJECTILE HIT A RIB AT ENTRY (INSIDE FACE OF ENTRY AND OUTSIDE FACE OF EXIT ARE SHOWN)

Figure 6. At the tank exit side, the tumbling projectile hit the panel between two ribs and left a 1 3/4-inch-long slit in the laminate (Figure 7). The panel skin showed a 2 1/2-inch X 1-inch hole with some petalling (Figure 8). In the case where the projectile hit a rib of the panel at the tank entry side, the rib ruptured and was deformed. The corrugated laminate kept the damage low and reduced the entry hole to the point where it almost sealed. This can be seen in Figures 9 and 10. The panel at the tank exit side was hit by the tumbling projectile which did not penetrate the panel skin. This is illustrated in Figures 9 and 10.

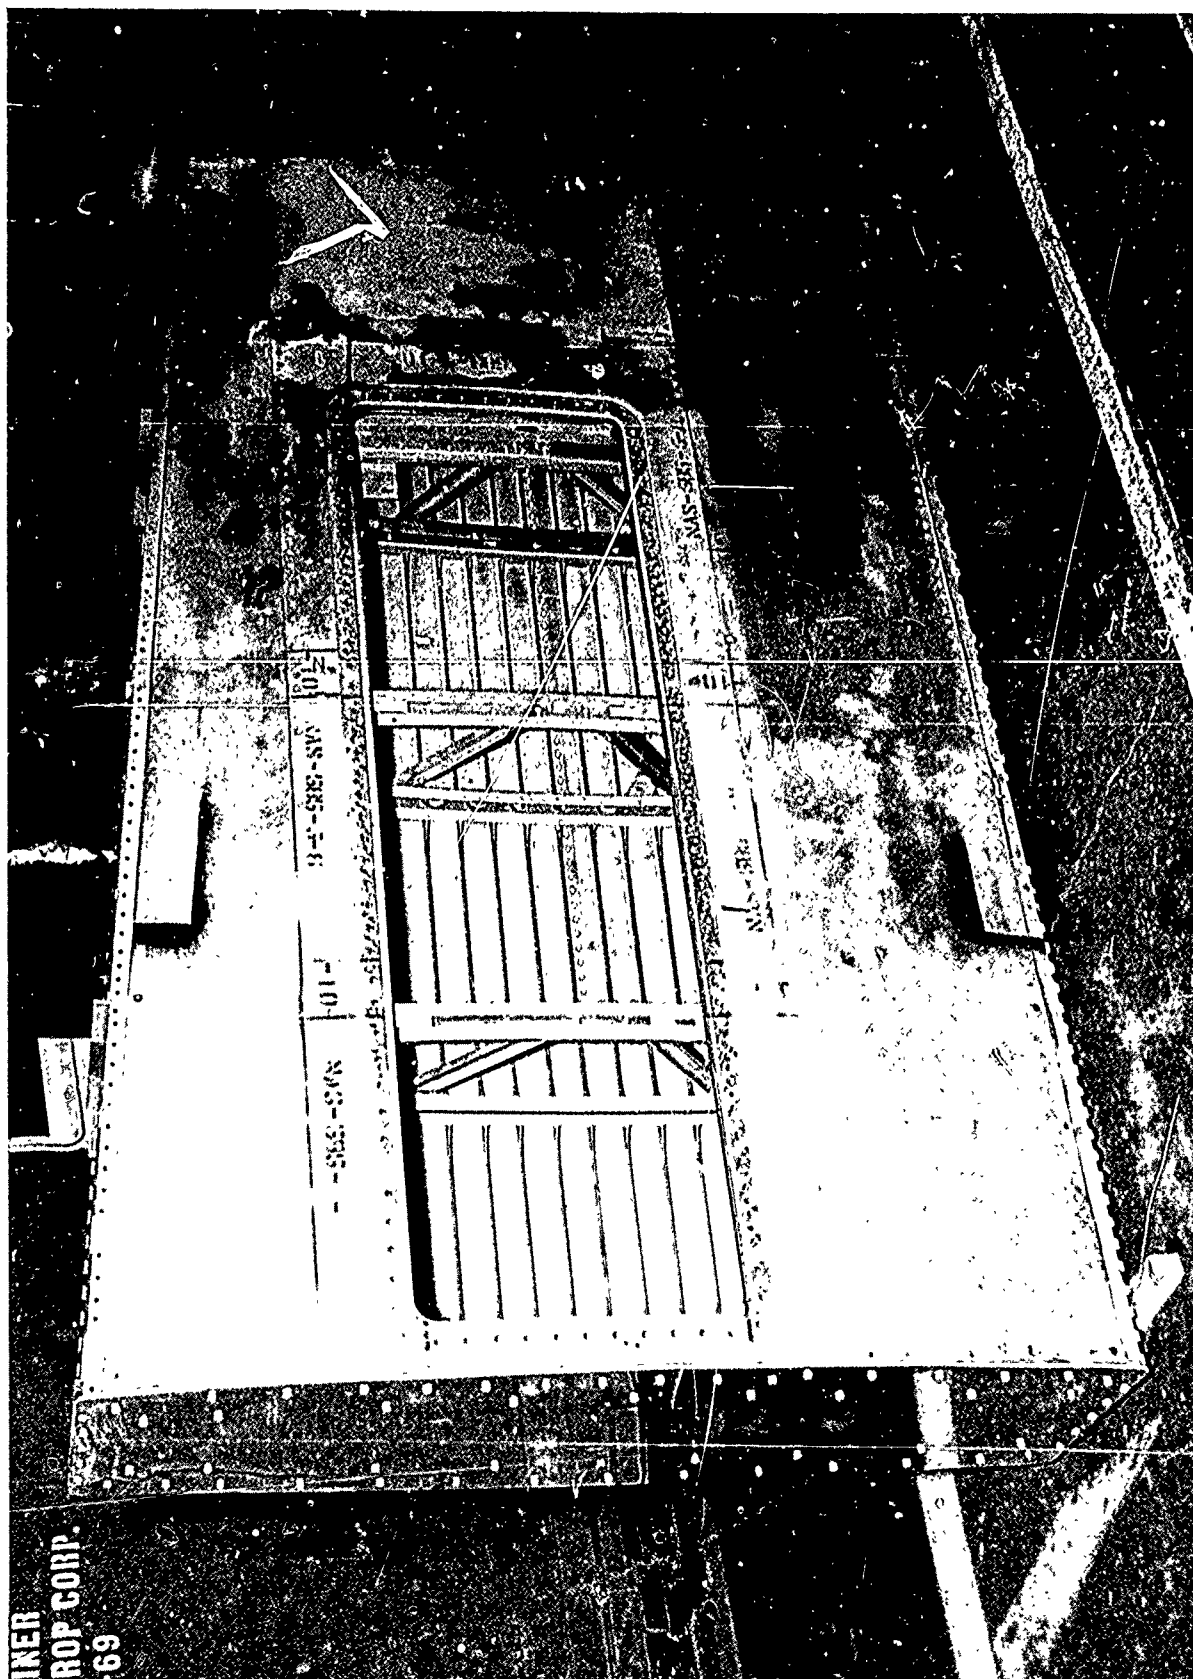
FIGURE 15. C-130 SLOSH AND VIBRATION TEST WING TANK

Figure 15 shows this particular section. The other section (OWS 421 to OWS 491) of the number three tank was cut up for use in evaluating methods for attachment of the damage control and self-sealing systems, for preliminary firing tests, and for preparing a mold to be used in the fabrication of the corrugated laminates. The skin thickness of section OWS 491 to OWS 562 varied from .050 to .040-inch and the rib thickness measured 1/16-inch.

As can be seen in Figures 15 and 16, which show the slosh and vibration test tank and the firing test tank, one side of each tank is tapering off as one proceeds in the outboard direction. The other side remains straight or untapered. On the untapered side, the corners, from one bay to the next,

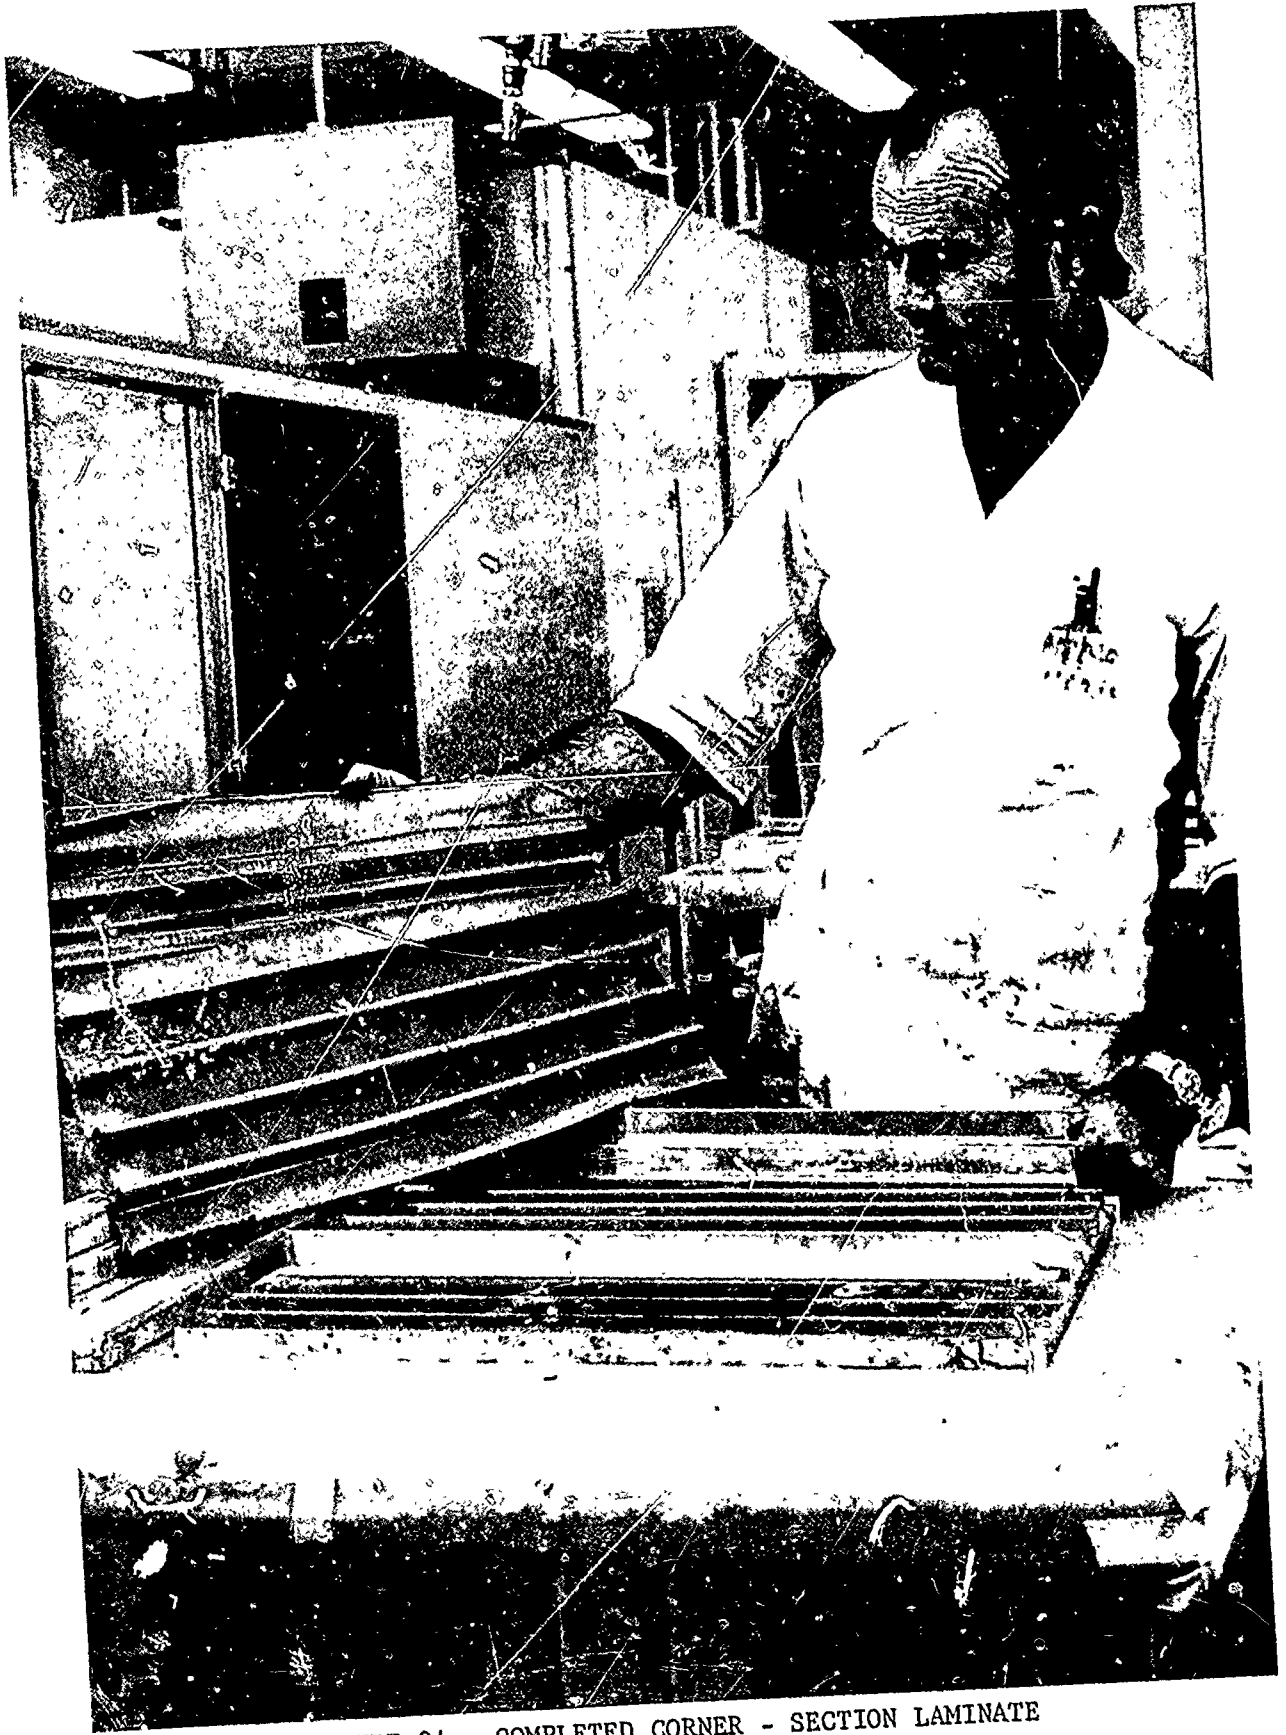
FIGURE 24. COMPLETED CORNER - SECTION LAMINATE

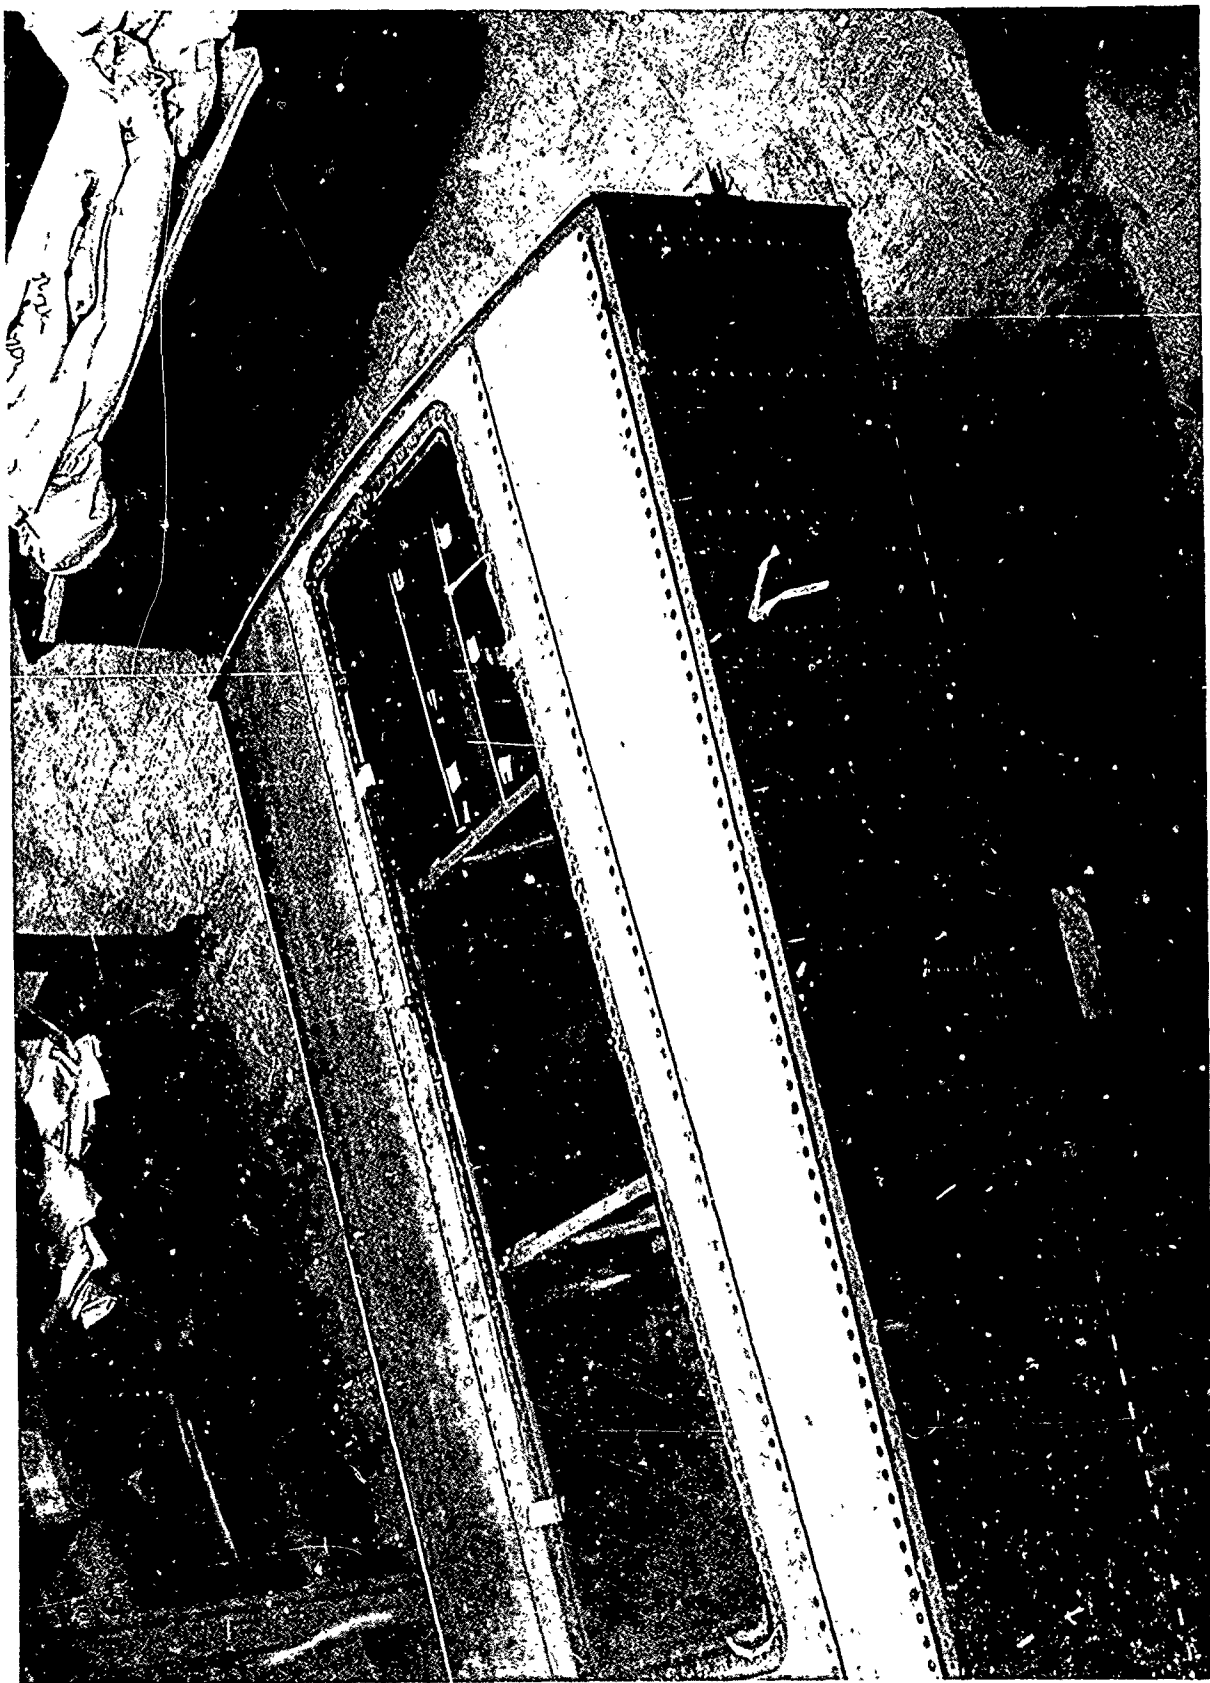
FIGURE 26. INSTALLATION OF THE CORRUGATED LAMINATE - TURN-BARRELS
PUT IN PLACE IN TANK BAY

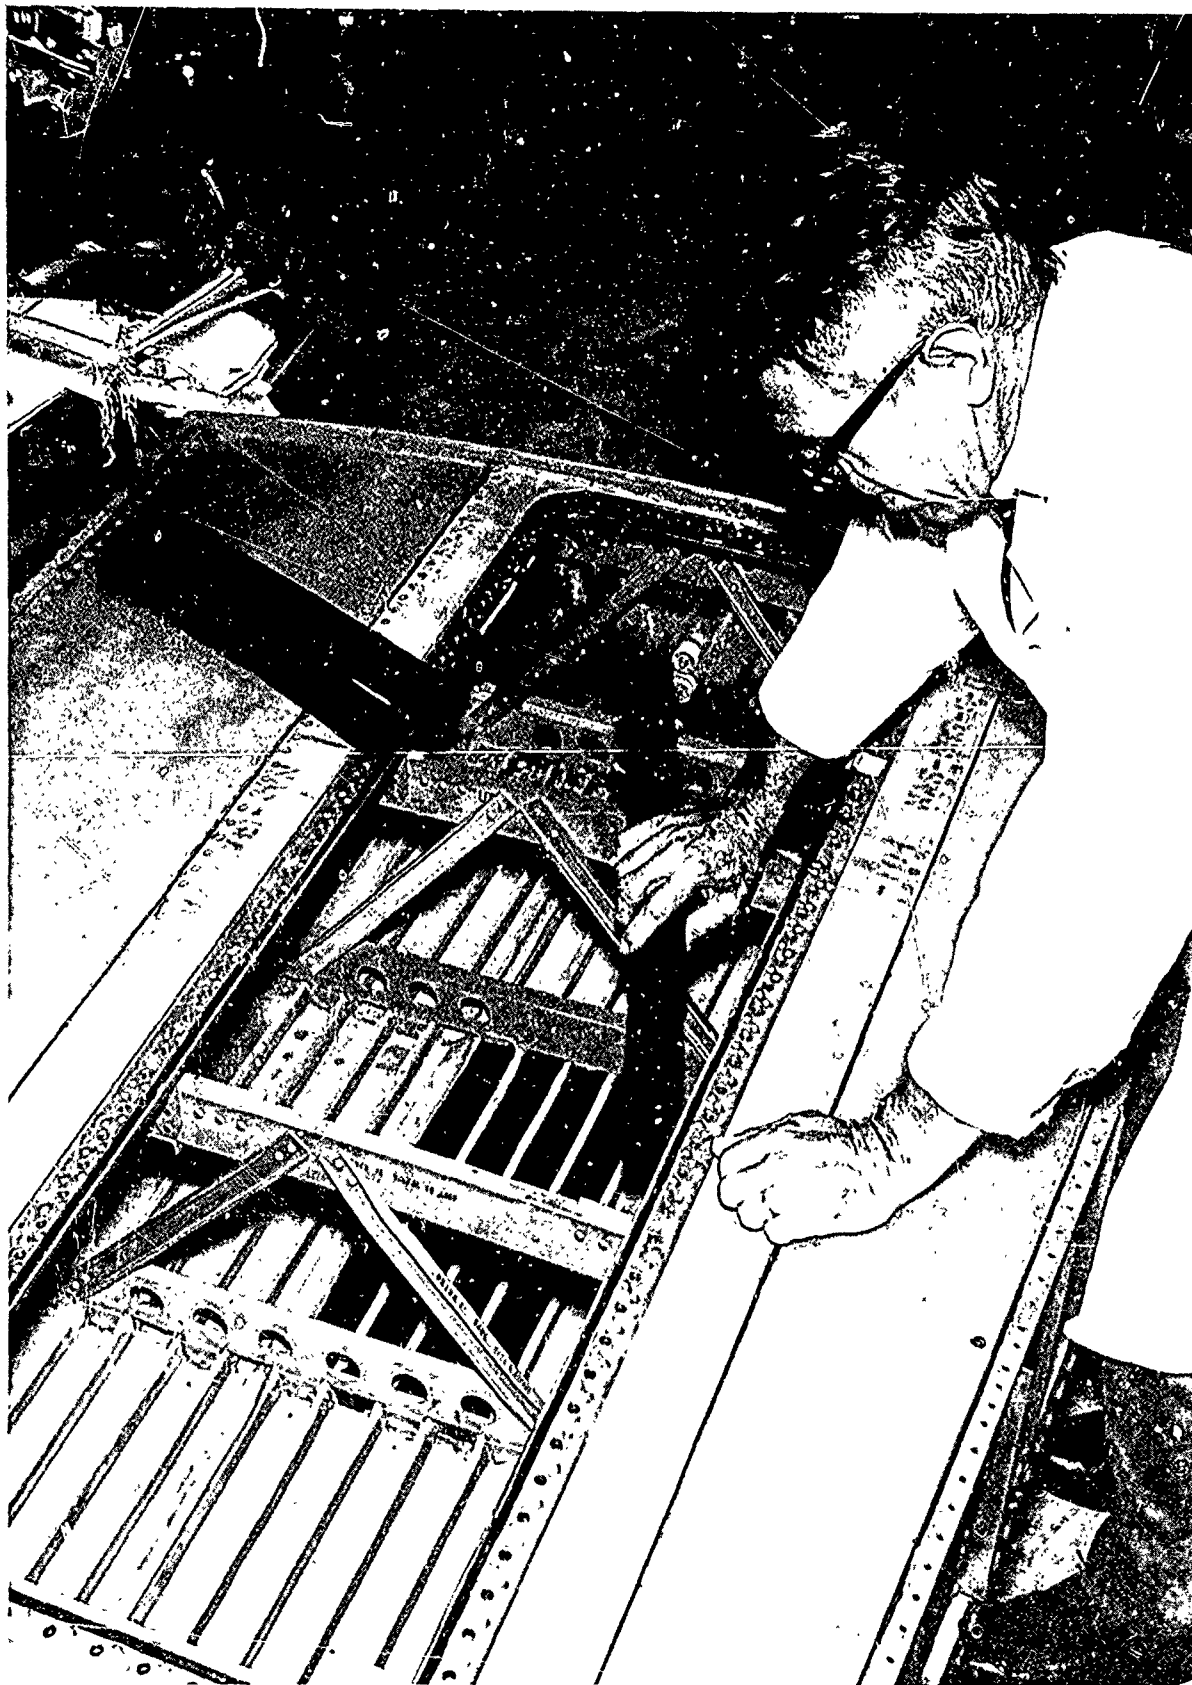
FIGURE 30. INSTALLATION OF THE PRECOMPRESSED FOAM IN TANK BAYS

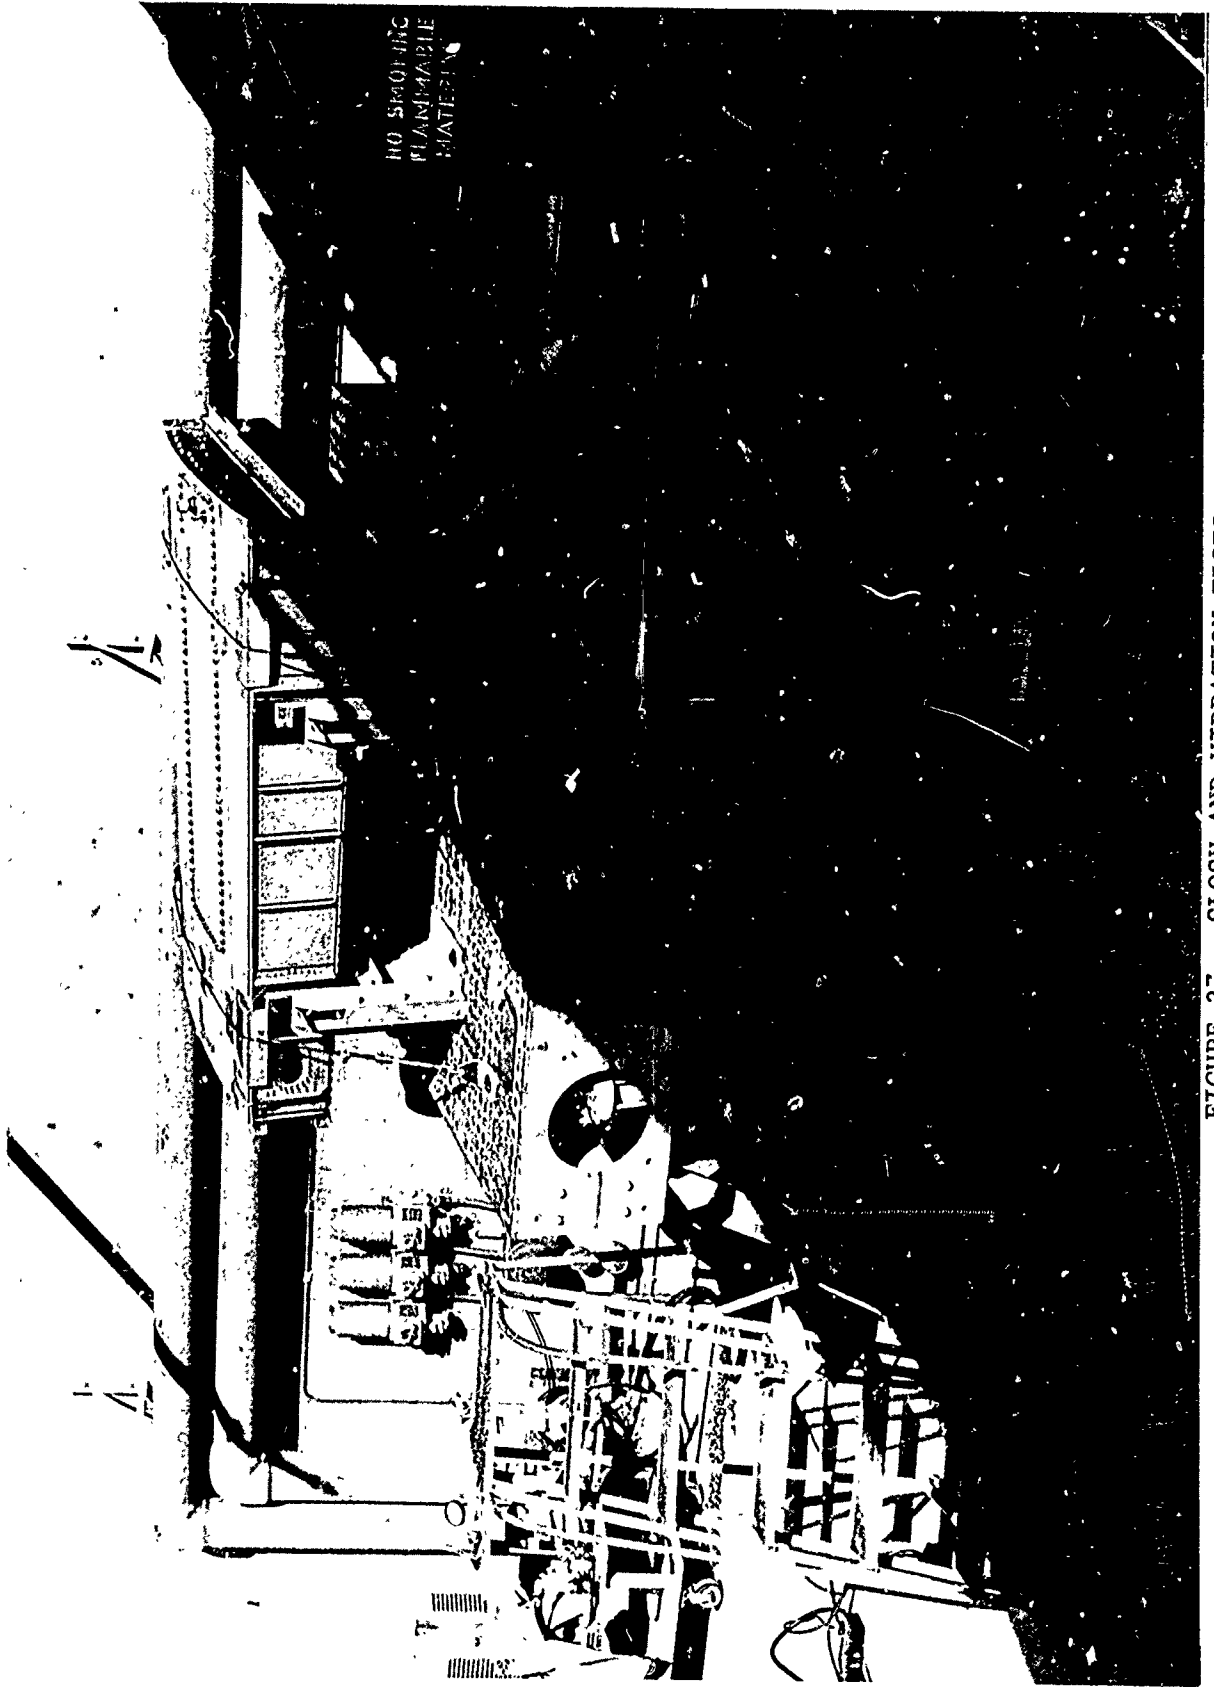
FIGURE 37. SLOSH AND VIBRATION TESTS

The tank was mounted (Figure 37) to the slosh and vibration table by means of a cradle assembly and straps. The tank was filled two-thirds full of JP-4 fuel (approximately 115 gallons).

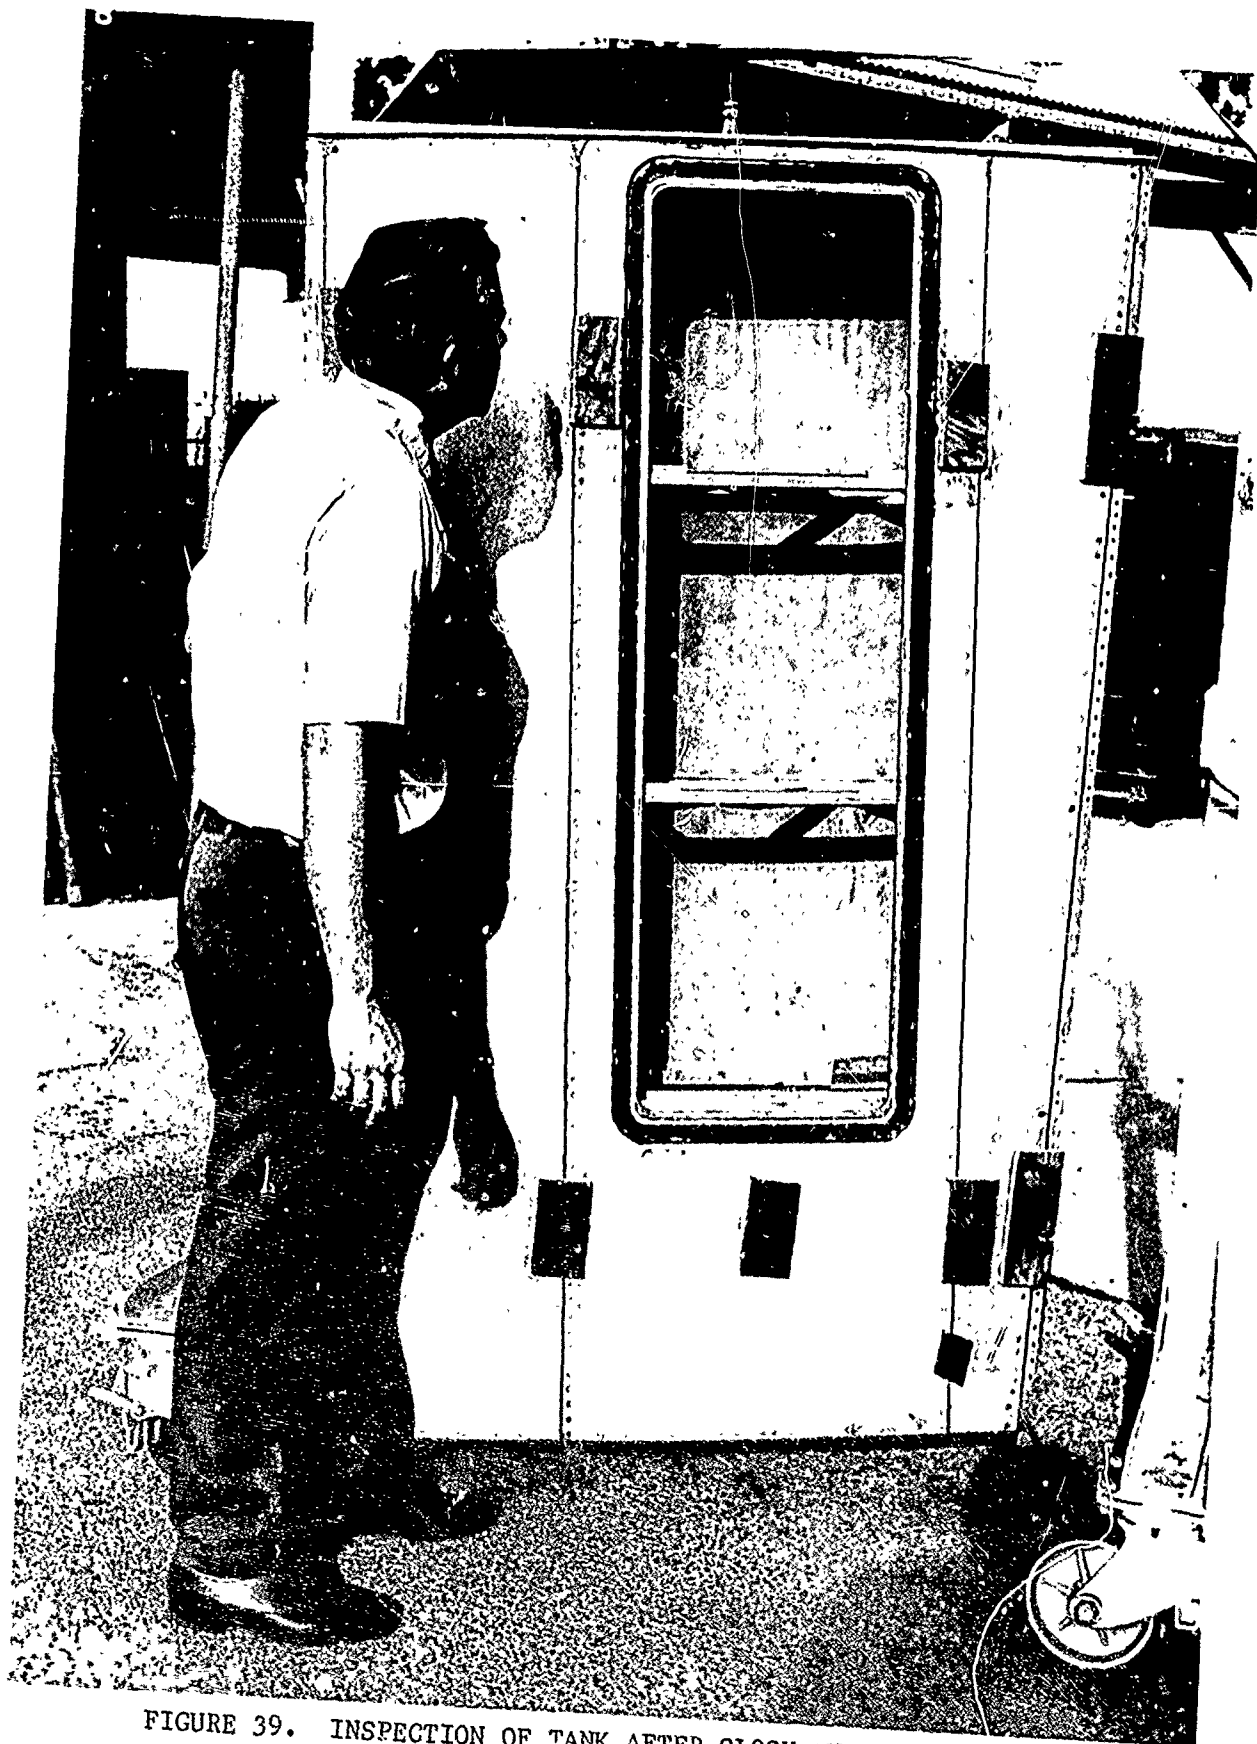
FIGURE 39. INSPECTION OF TANK AFTER SLOSH AND VIBRATION TESTS

1. No evidence of delamination or tearing of the damage protection and self-sealing systems (Figure 39).
2. Two failed vertical trusses in the Stations 509 and 526 rib structures.

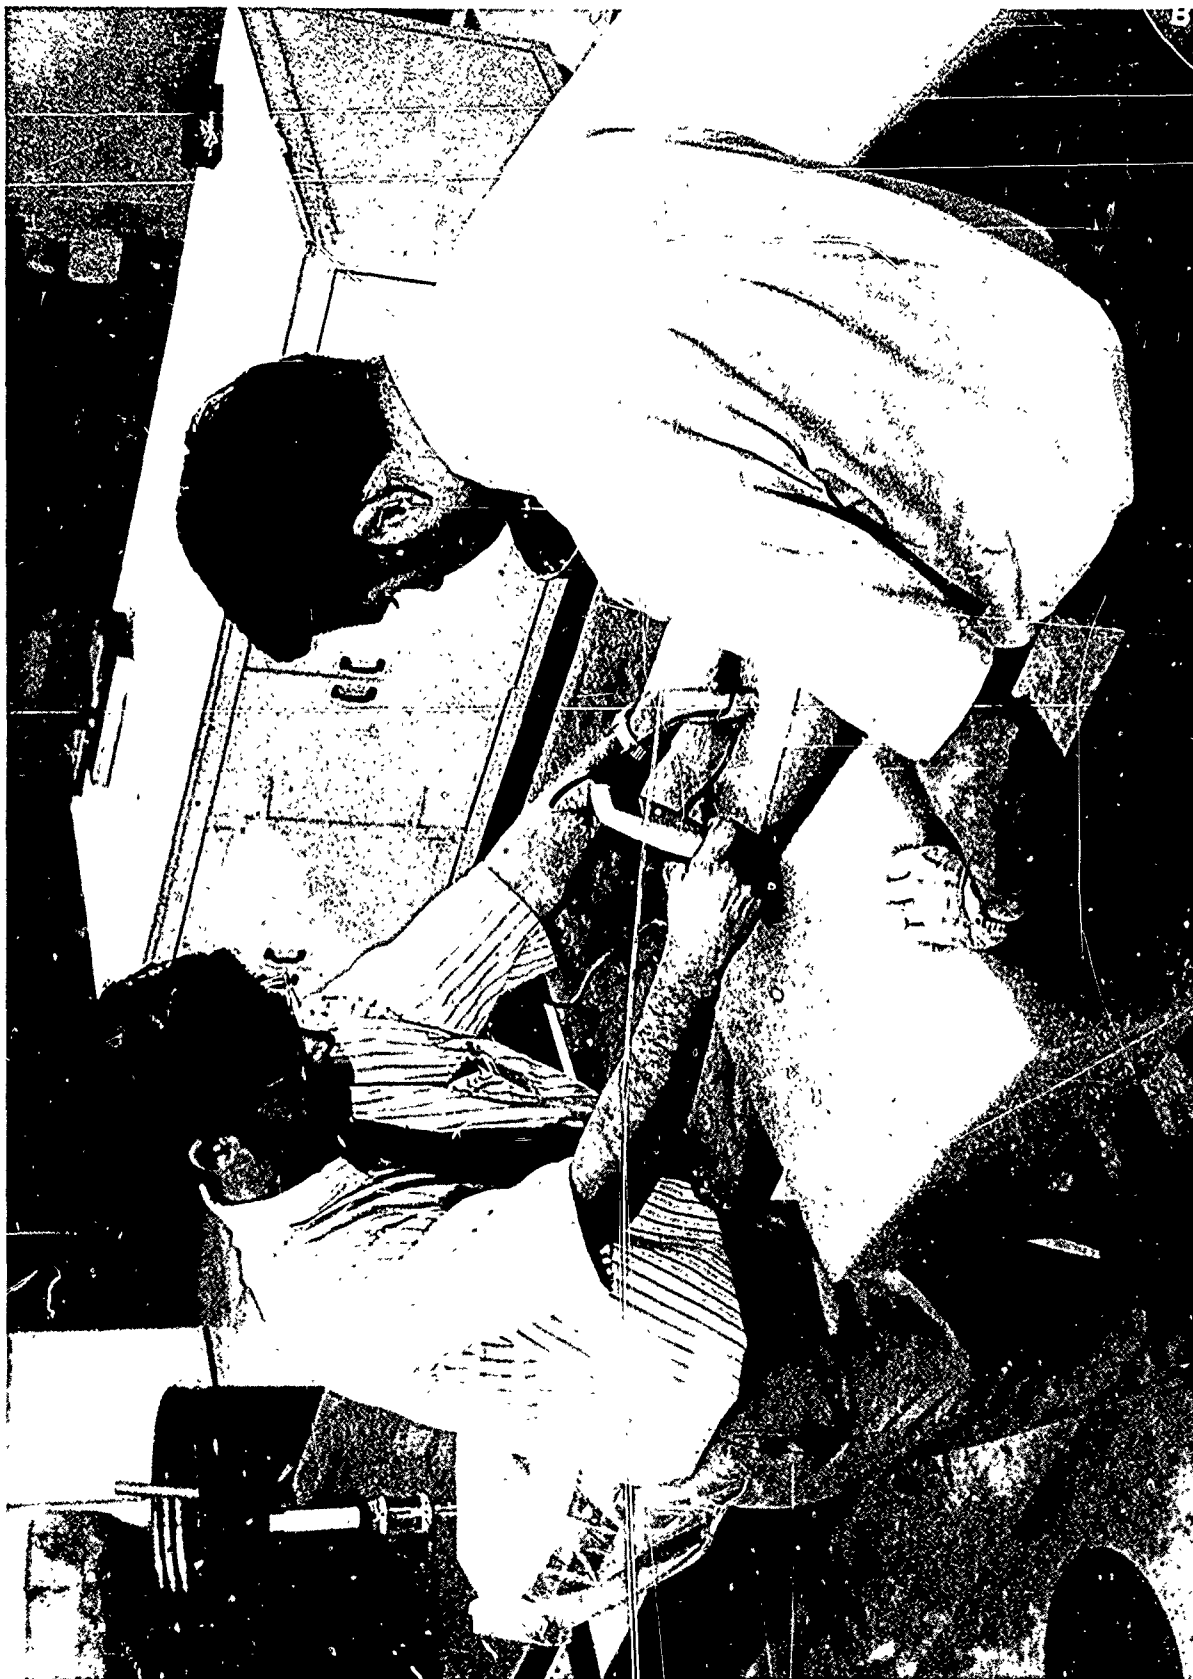
FIGURE 40. CUTTING OF RETICULATED FOAM

After the installation of the self-sealing system and the damage control system in the bottom and top sections of the firing test tank, the reticulated foam (orange type) was cut (Figure 40) to fit and installed inside the tank as shown in Figure 41. The two covers were then bolted on top of the tank. The outside bottom part of the tank was spray-painted white and marked as shown in Figure 42.

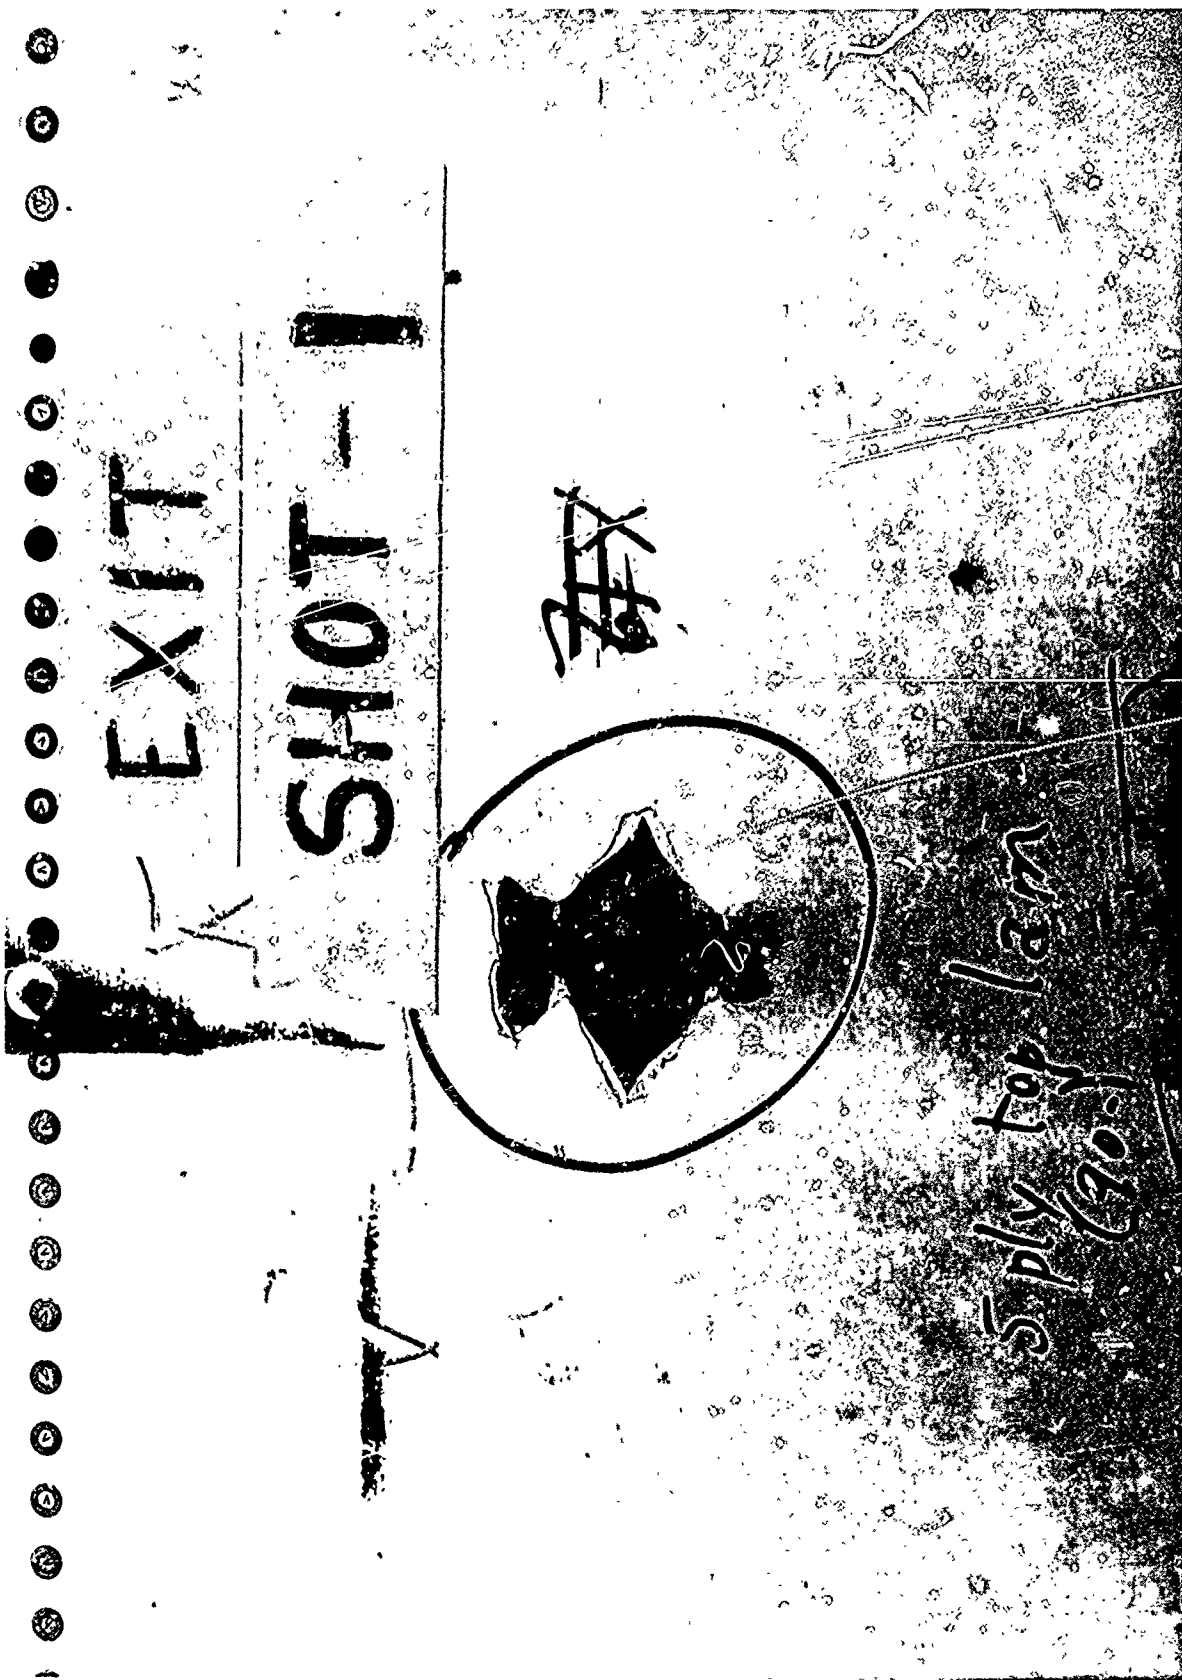
FIGURE 47. TEST NO. 1, .50 CALIBER AP VERTICAL - EXIT FACE OF THE TANK

The projectile exited the tank in a fully tumbled condition as Figure 47 shows. A 3-inch X 3-inch piece of metal skin was removed. The butt and tip of the projectile each hit a rib and ruptured them. The corrugated laminate (five-ply) shows a 2-inch long slit. While traveling through the tank, the projectile did not hit other segments of the tank structure. In a scaled sketch of the tank (Figure 48), the points of entry and exit and the path of the projectile through the tank are given.

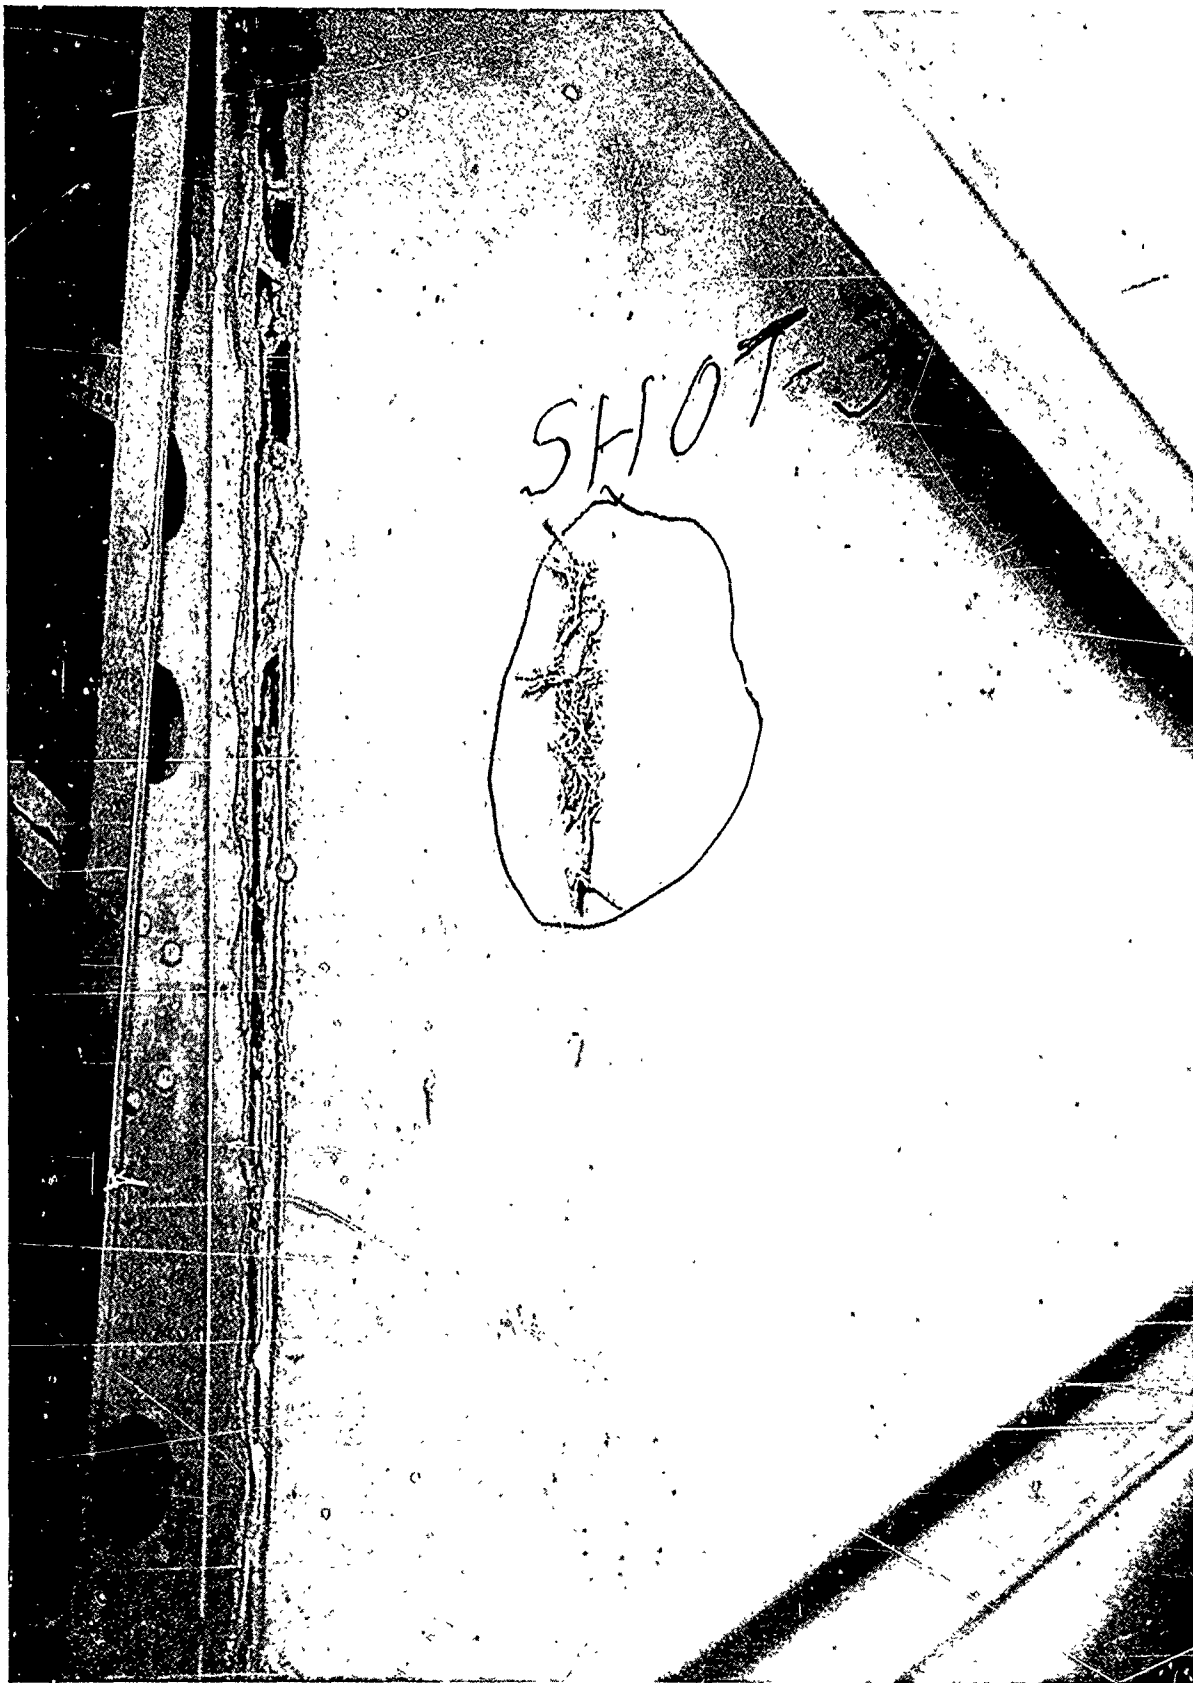
FIGURE 53. TEST NO. 3, .50 CALIBER AP, 45° FROM VERTICAL -
PLAIN LAMINATE BEHIND THE ENTRY WALL IS SHOWN

The projectile penetrated in a 45° angle of incidence and hit a rib longitudinally as shown in Figure 52. The projectile tumbled immediately behind the entry metal skin and exited the plain laminate or the entry skin in a fully tumbled condition. This was ripped as is shown in Figure 53. This sudden tumbling of the projectile right behind the entry wall and the rupturing of the rib dumped a tremendous amount of energy at this spot and produced a high pressure ram wave. This provoked a long crack (approximately 39 inches) and some petalling at the metal skin entry wall, as is shown in Figure 52. The leakage recorded was 3.2 liters/min. After the entry, the tumbling projectile proceeded through the tank. Before it was stopped inside the tank, it fractured two vertical trusses (OWS 334 and OWS 317) and hit part of the cover. The hit cover and one of the hit trusses are shown in Figure 54. The projectile was recovered in the reticulated foam next to that fractured truss. On the sketch in Figure 48, the points of impact of the projectile and its trajectory through the tank are shown. Coverage with the high-speed motion picture cameras was obtained of this shot.

The distorted truss shown in Figure 53 was caused by the 20 mm. AP impact and not by this No. 3 shot. The 20 mm. shot is described below.
